The Presidio Park Graben San Diego, California

Mike Hart
Hart Geologic Services
mwhart@aol.com

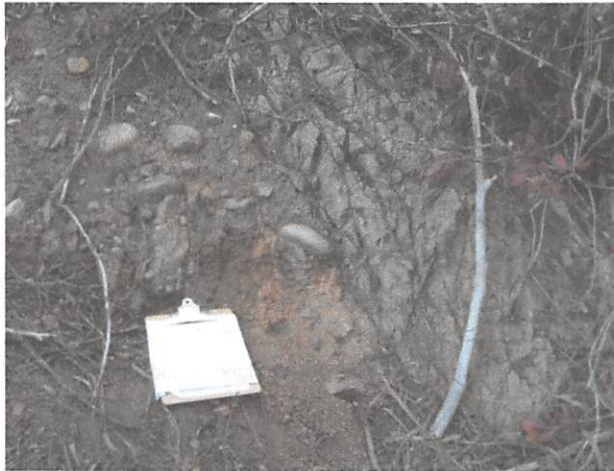
Figure 2. The south graben fault juxtaposing Lindavista Formation on the left and Mission Valley formation on the right. (Location B, Geologic Map, Figure 1)

The southern fault that defines the graben is exposed at two localities; along a trail on the west side of the northwest trending ridge south of the previously described parking lot (Location B, Figure 1, and Figure 2,) and in the road cut leading to the parking lot described above. At this locality the fault juxtaposes red-brown sandstone of the Lindavista Formation with light-brown thinly-bedded sandstone of the Mission Valley Formation. In the northeast corner of the mapped area the southern fault is accompanied by a closely parallel fault.. These two faults define a secondary down-dropped block of Lindavista formation. The most northerly of the two faults dips 70 degrees to the southeast (location C, Figure 1).

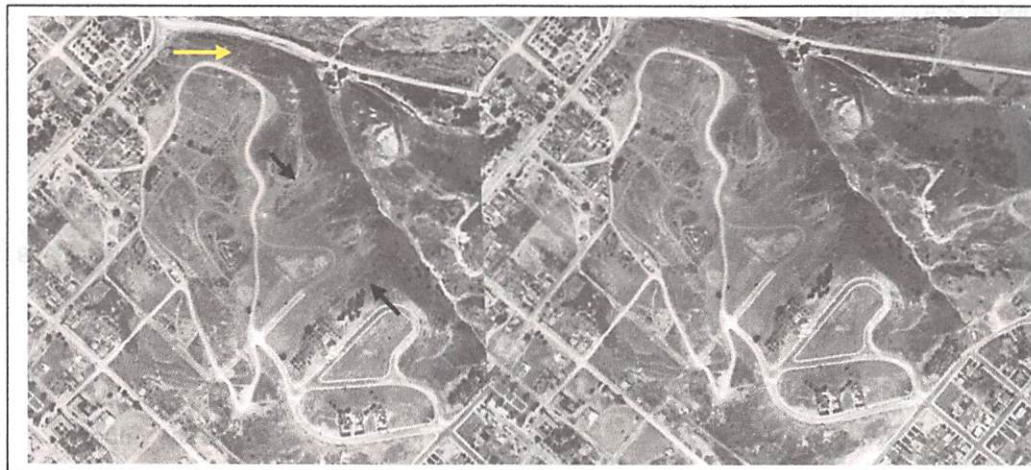
Figure 4. San Diego County 1928 photographs of Presidio Park area. Black arrows point to northeast trending fault scarps bounding the Presidio Park Graben. Yellow arrow points to possible right-lateral offset of valley wall. Geologic map Figure 1 shows an uphill-facing possible fault scarp and closed drainage south of the road below the yellow arrow that may be evidence of a landslide or an active fault.

Presidio Park is located adjacent to and northeast of Old Town State Park in the southeast quadrant formed by Interstate 8 on the north and Interstate 5 to the west. Because of its unique location on the east side of the Rose Canyon fault and the fact that the area has escaped development by virtue of being designated a park; this area displays some unique and extremely interesting tectonic features. As a result of geologic mapping during a geologic study for a residential development in Old Town, a previously unrecognized graben, three north-south striking minor faults, and a probable fault manifested by an uphill-facing scarp and possible offset of the southern wall of Mission Valley were discovered in the park (Figure 1). The two northeast-striking graben-bounding faults are well-expressed on topographic maps and on aerial photographs (Figures 1 and 4). Vertical slip (throw) on the southernmost fault is nearly 100 feet.
